Debris/Ice/TPS Assessment and Integrated Photographic Analysis of Shuttle mission STS-97

Technical Memorandum – 2001 – 208589

January 2001

November 30, 2000

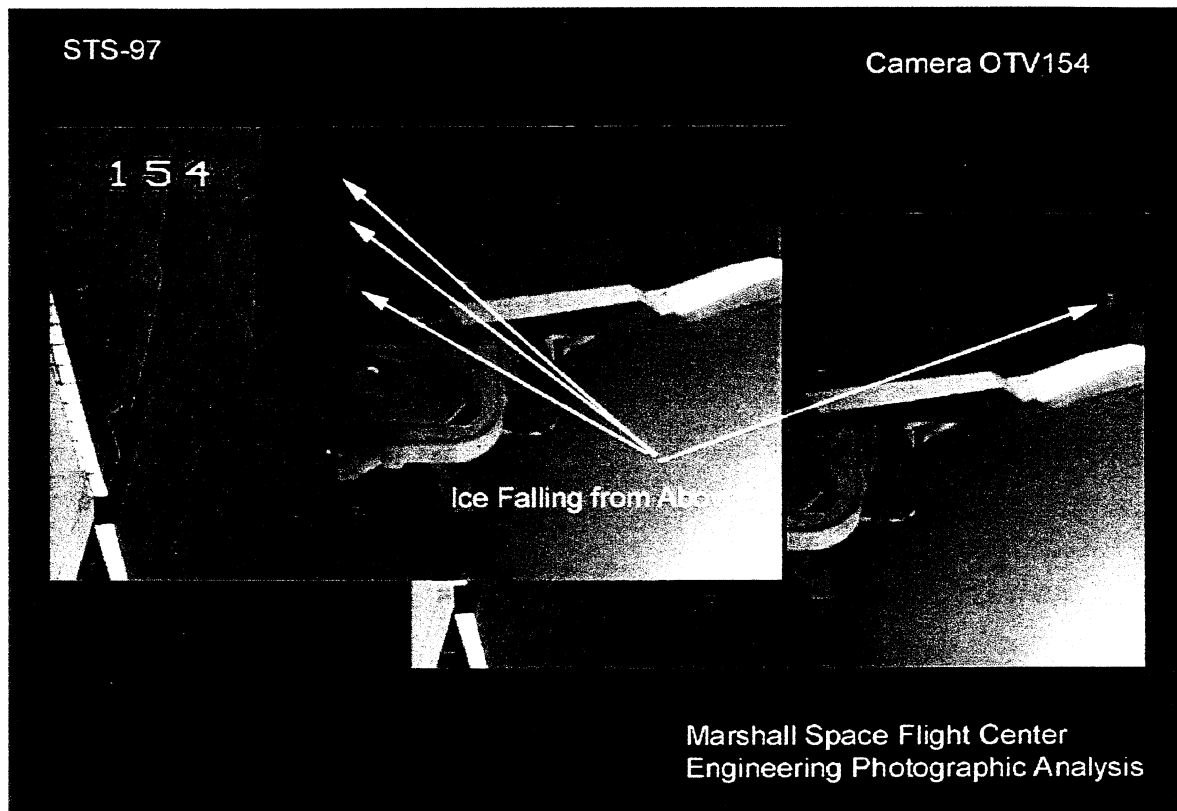
Figure 2. Ice from 17inch Disconnects

Typical ice from 17-inch disconnect was noted. Also, ice fell through the field of view from possibly two sources forward of the disconnect. One source of debris apparently came from near the Orbiter and the other near the right SRB.

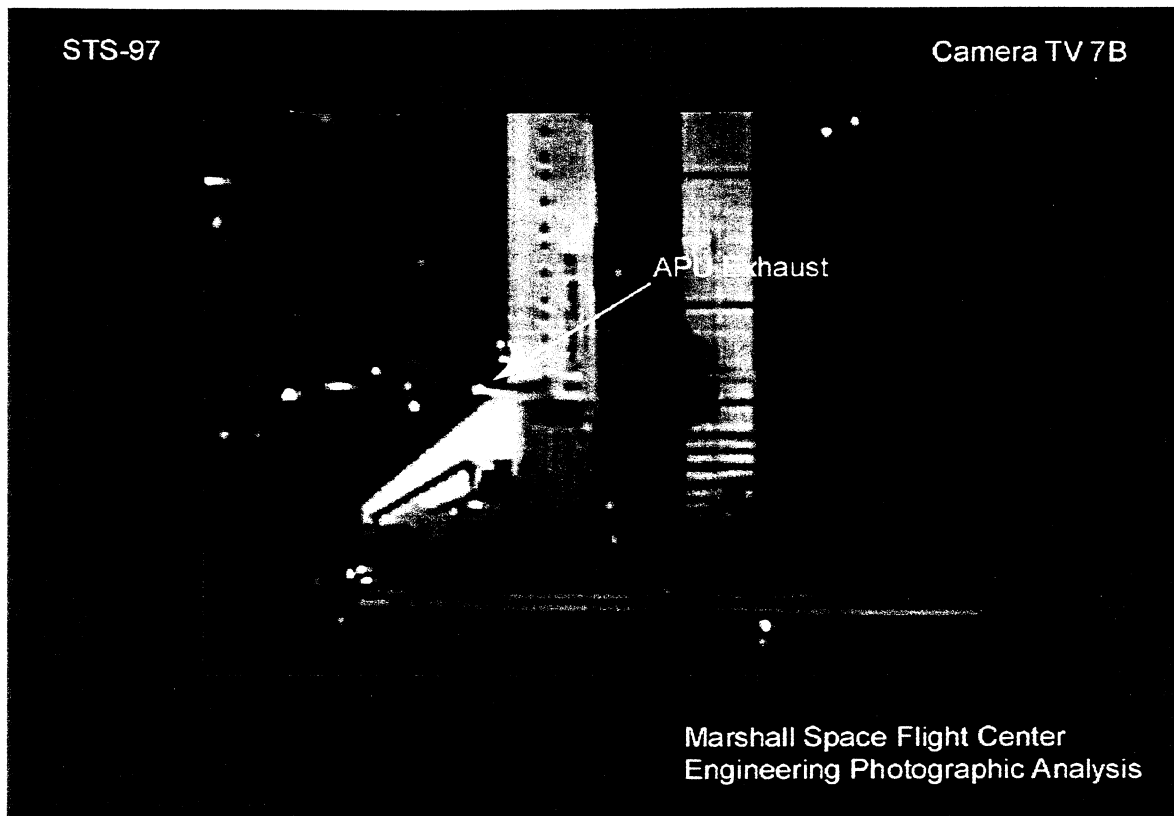
Figure 4. Side View: APU Exhaust Flame Prior to Lift-off

Figure 4 is a side view of the Orbiter on the launch pad prior to lift-off that illustrates the extent of the APU exhaust flame.

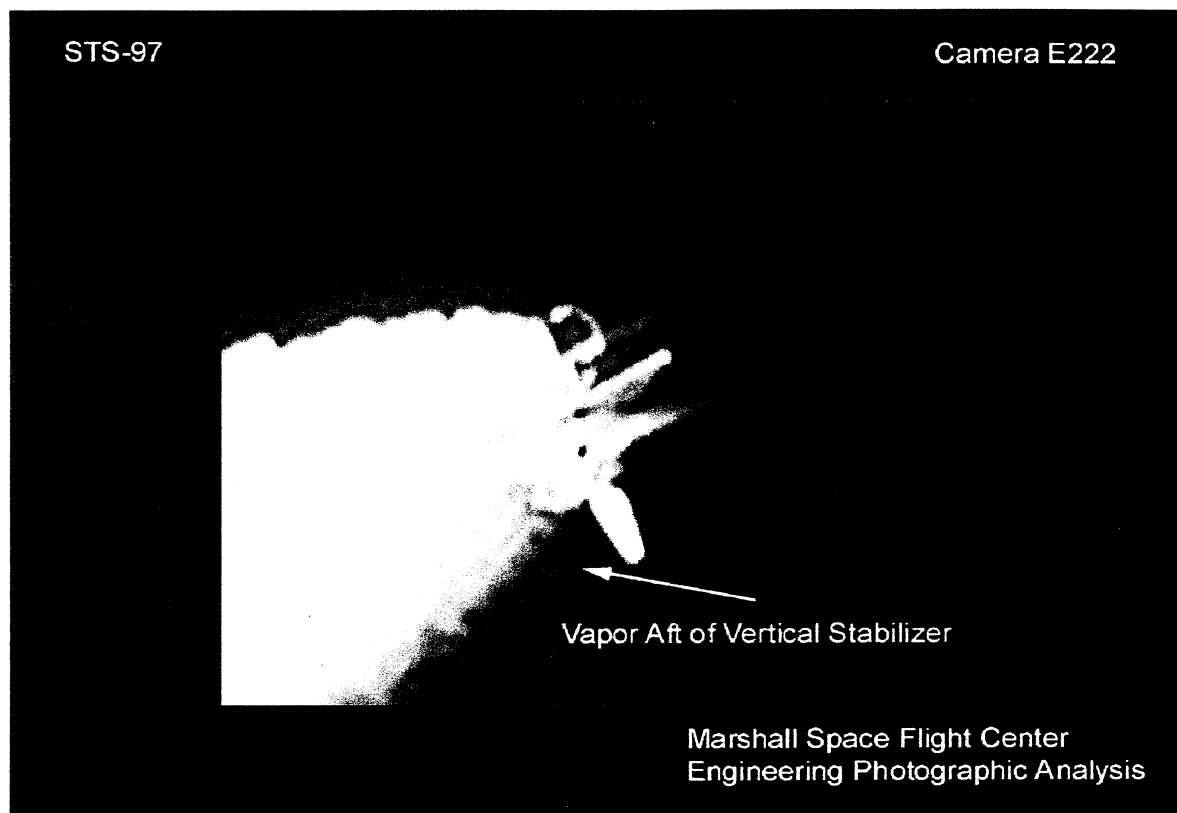
Figure 7. Vapor from Vertical Stabilizer

Vapors, or possible impact debris, emanating from near the middle section of the aft edge of the vertical stabilizer were observed during ascent from approximately 336:03:06:45.7 UTC until 336:03:06:46.9 UTC.
